Insulating Biomaterials N01-NS-2-2347

Fourteenth Quarterly Progress Report January-March, 2006

Neural Prosthesis Program

InnerSea Technology

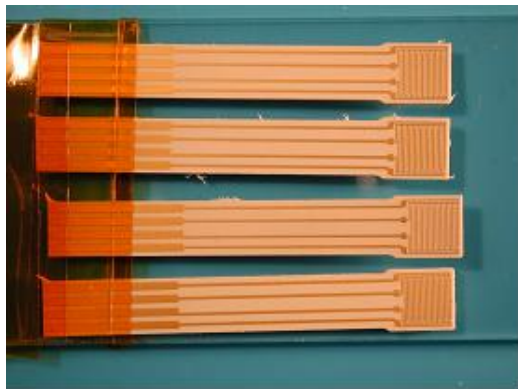
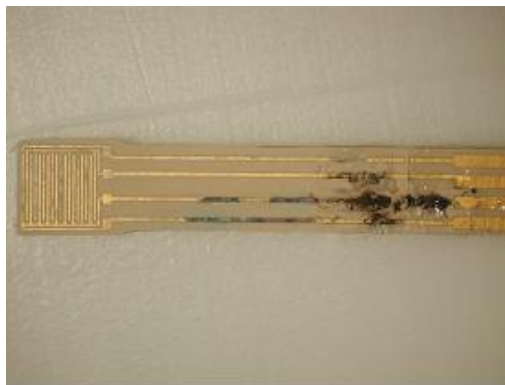
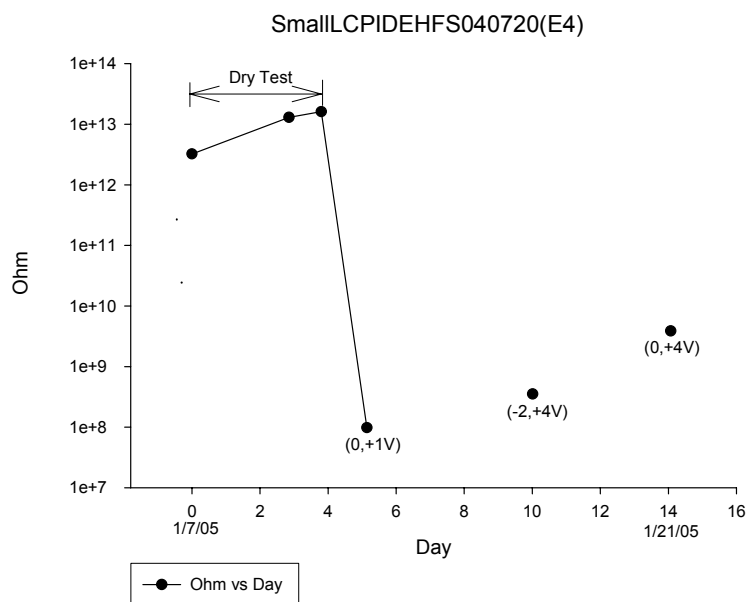
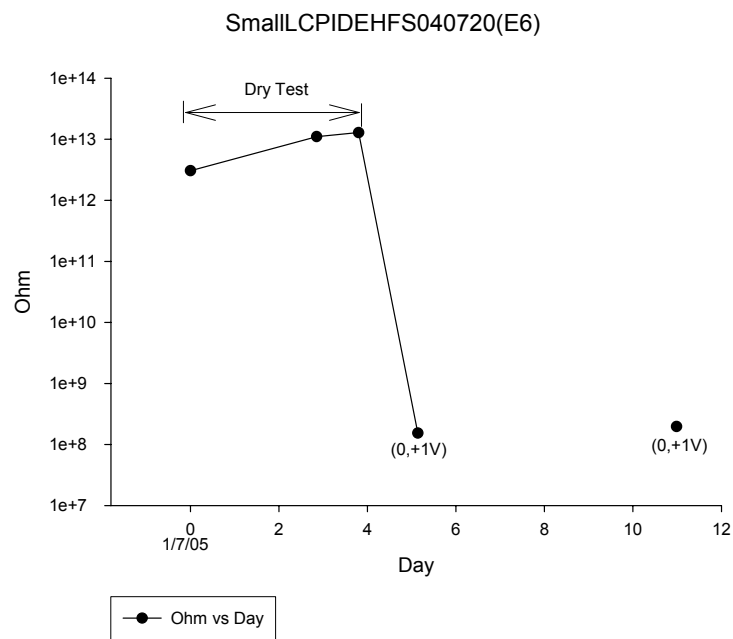
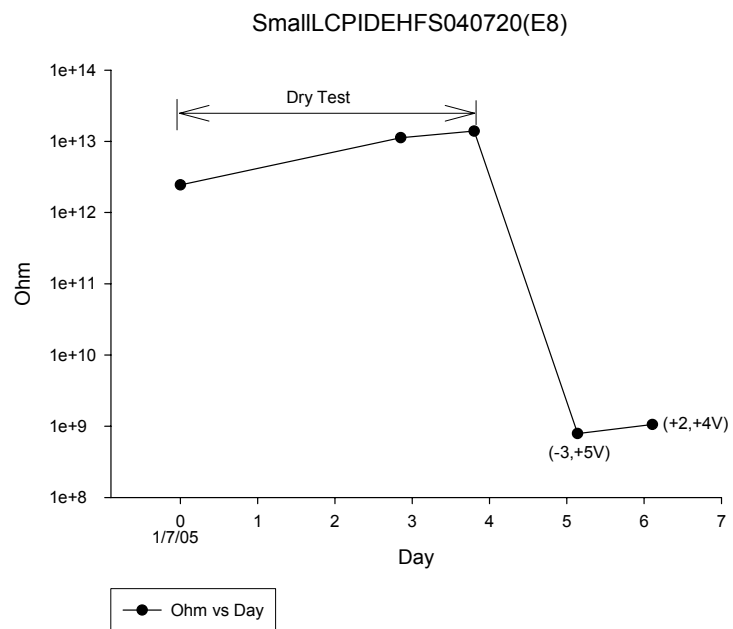
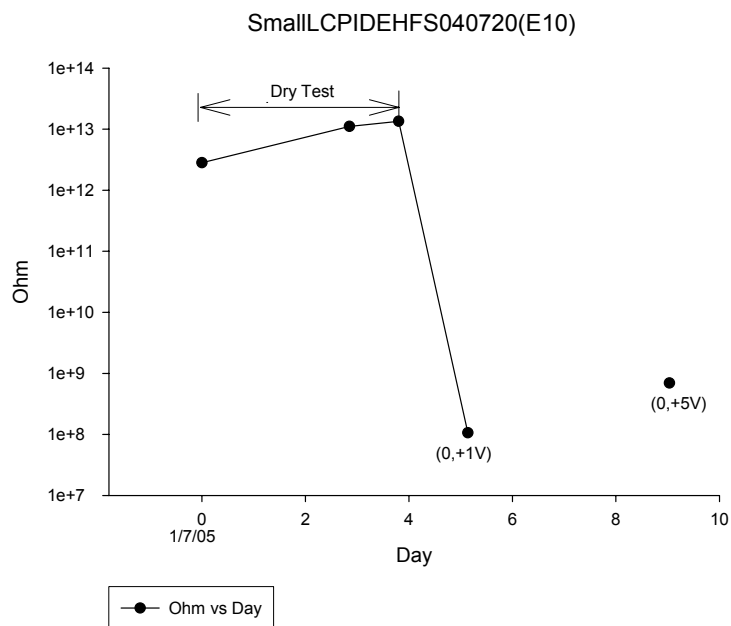
Four small LCP IDEs coated with CVD silicone (see below) were assembled into a test jar. The devices were initially tested without solution (dry test). In a five-day measurement, the devices had resistance at 10^{12} to $10^{13}\Omega$. However, after the test jar was filled with Phosphate Buffered Ringer (PBR) on 1/12/05, all the devices were failed within the first two measurements. The pass test was terminated on 1/24/05 and the resist data are summarized in Table1. Microscopic study showed that for all the devices,

extensive corrosion was found on the leads especially at the region where the samples were fixed to the cap by quick cure silicone (MED2-4220). Perhaps there was physical tension from silicone MED2-4220 which weakened the CVD silicone coatings on the substrates, particularly over the metallization where there would be little adhesion. While extensive corrosion was also found on the IDEs for device E08, no corrosion or minimum corrosion was observed on the IDEs for E04, E06, and E10 respectively.

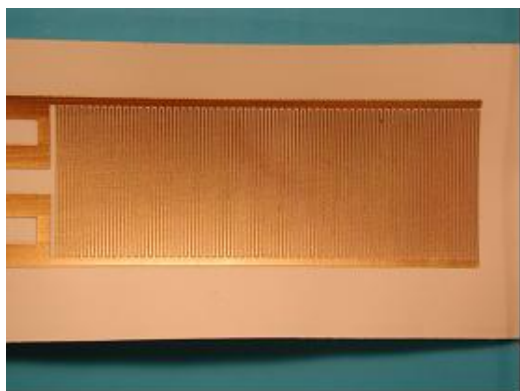
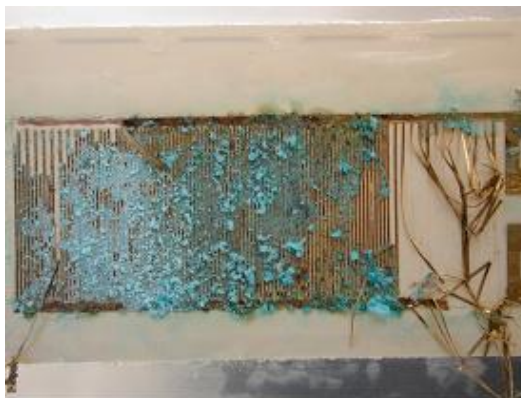
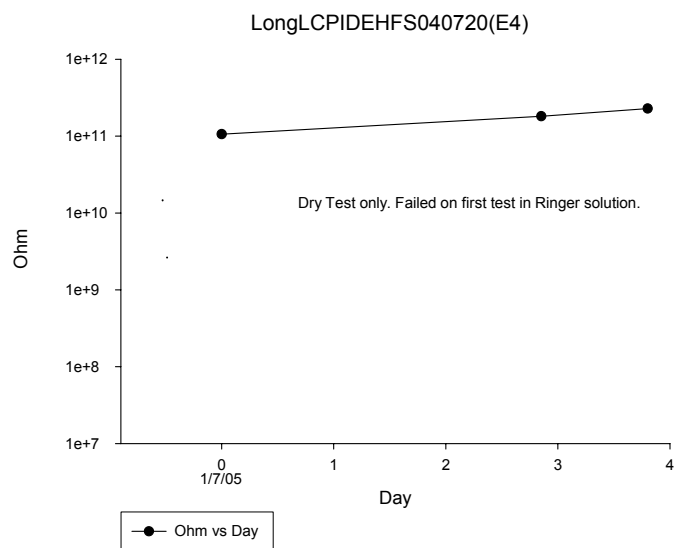
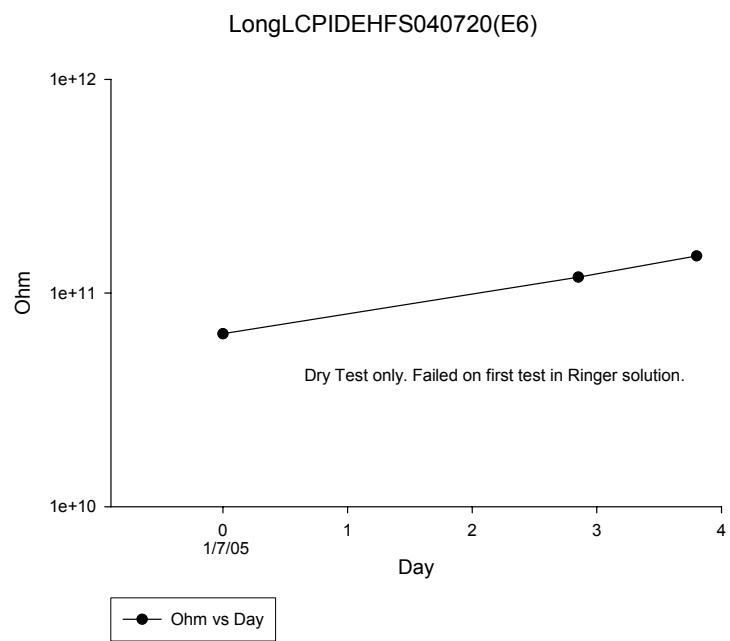
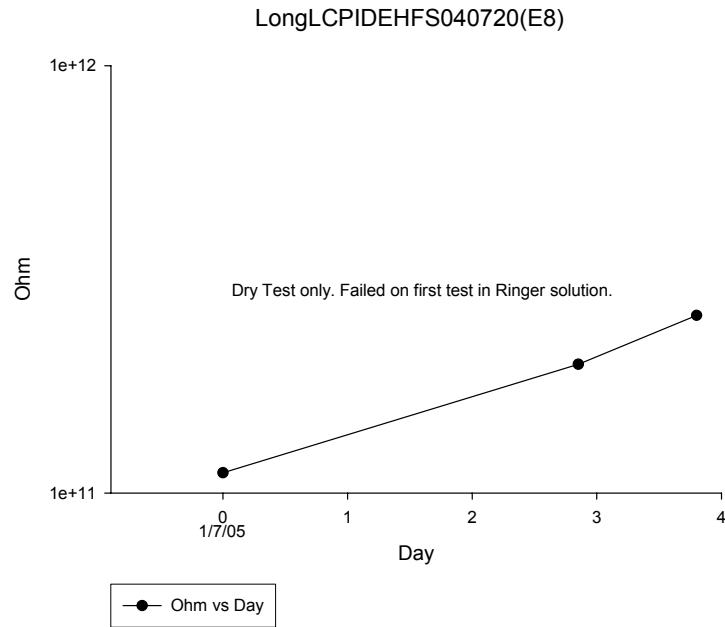
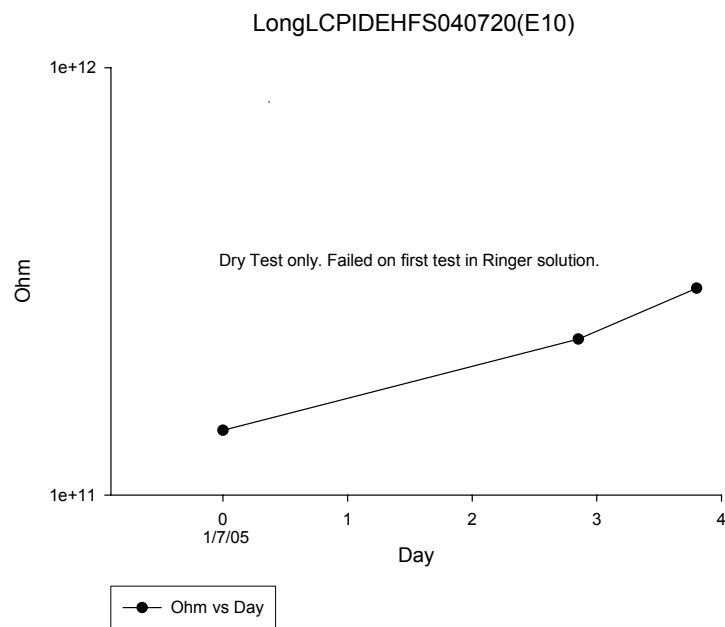
LongLCPIDEHFS040720

Four long LCP IDEs coated with CVD silicones were cut short and assembled into a test jar as outlined above. A five-day dry test showed the devices had the resistance of $10^{11} \Omega$. After the test jar was filled with Phosphate Buffered Ringer (PBR) on 1/12/05, all the devices were over ranged on the first measurement. The pass test was terminated on 1/24/05 and the resist data are summarized in Table2. Microscopic study showed green bluish copper corrosion products all over the triple tracks for all four devices.

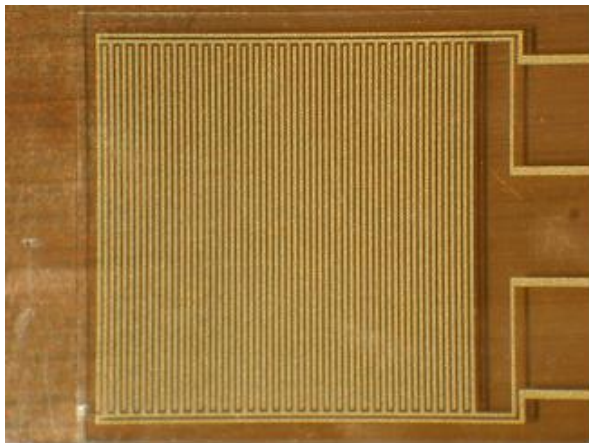
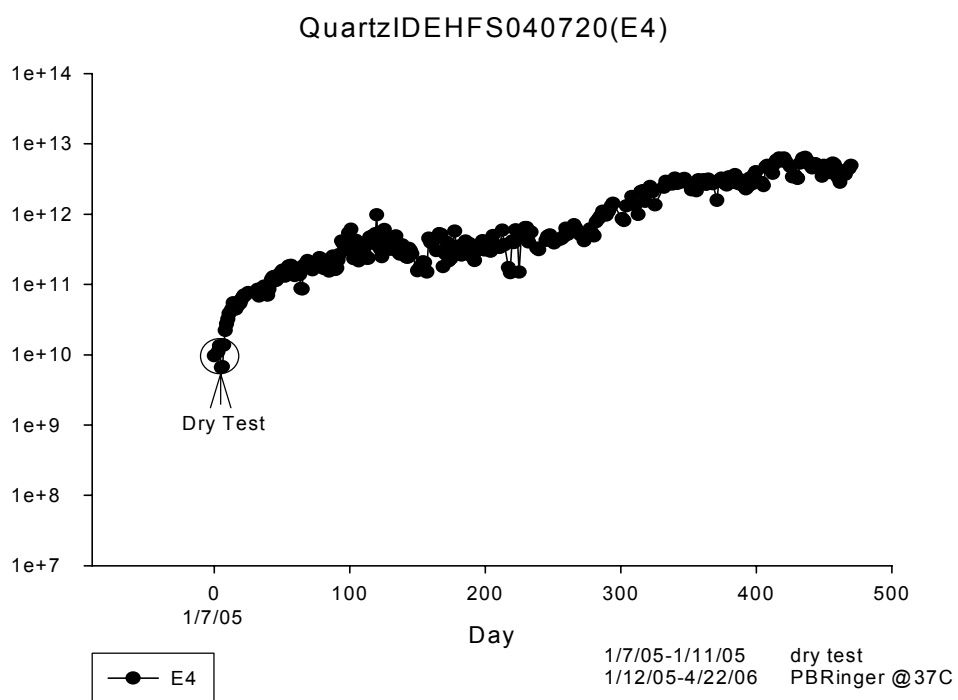
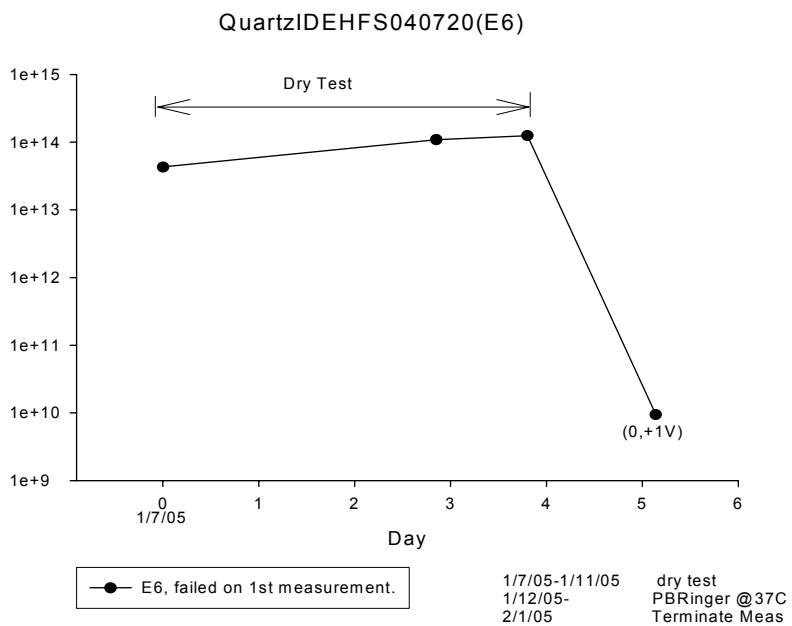
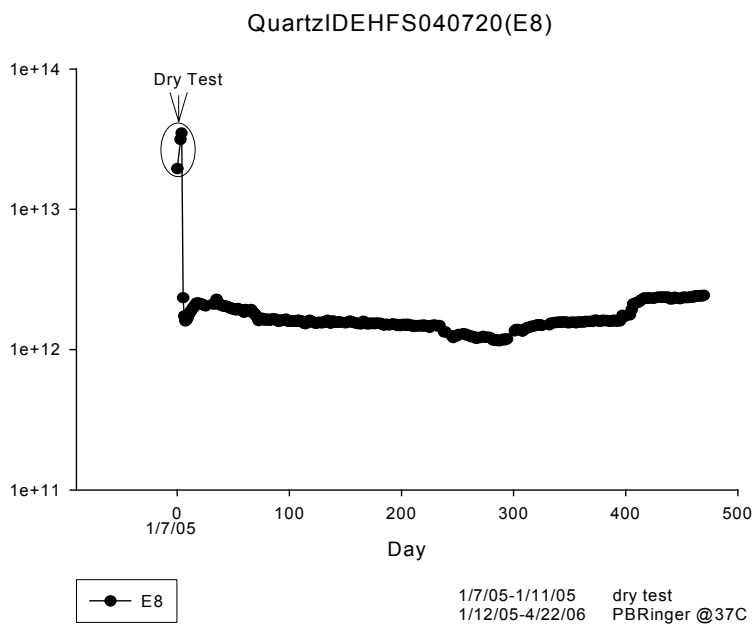
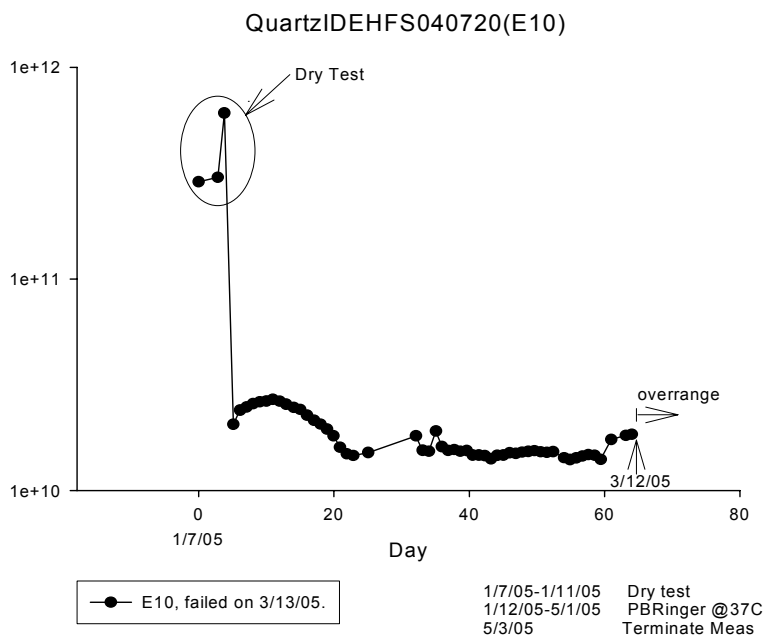
QuartzIDEHFS040720

Four quartz IDEs coated with CVD silicone were assembled into a test jar. Dry test showed the devices E4 & E10 had resistance of 10^{10} and $10^{11} \Omega$ respectively, and E6 & E8 at $10^{13} \Omega$. After the test jar was filled with Phosphate Buffered Ringer (PBR) on 1/12/05, E6 failed on the first wet test and the measurement was terminated on 2/1/05. During 15 months testing, the resistance of E4 has gradually increased from 6.6×10^9 to $4.9 \times 10^{12} \Omega$ and E8 remains at $10^{12} \Omega$. Device E10 continues at $10^{10} \Omega$ level for a period

of two months and then suddenly failed on 3/13/05. E10 was terminated on 5/3/05. Corrosion on IDE is observed on both E6 & E10. Tests for E4 and E8 are continuing.

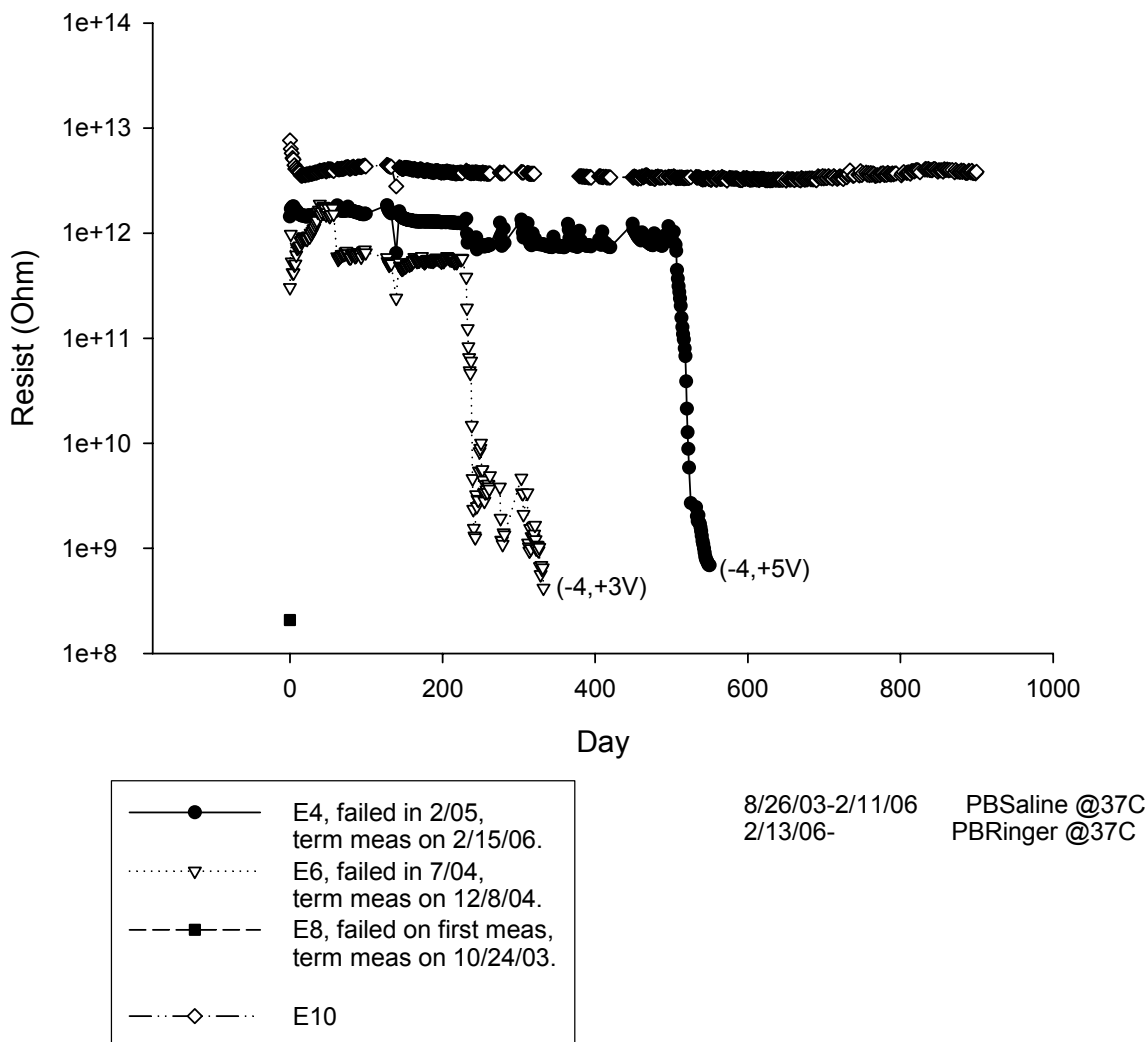
On 8/26/03, LCPIDE030603W & LCPIDE030603D began wet test in saline at 37°C. LCPIDE030603WE8 failed the test right way. Microscopic exam revealed that corrosion occurred at the exact location where the air bubble in silicone was found before the test (b_LCPIDE030603WE08_siliconeBubble_A42-B41L_20x & a_LCPIDE030603WE08_Corr_B41-A42_DF5x). It is also noticed that MED4-4220 used in this experiment behaved like quick cure silicone and thus thickened rapidly high, therefore easier to trap air bubble. The second failed device on the thinner LCP is LCPIDE030603WE6. The resistance of this device began at $10^{11} \Omega$, gradually dropped to $10^9 \Omega$ within 11 months test period, and remained at $10^8 \Omega$ with very limited bias range for another three months before completely failing. Triple tracks looked very clean after the test; however, microscopic exam revealed two spots of corrosion. One spot seemed to be early stage dendrite corrosion, which may be caused by electrolysis of Au under the bias at defect spot of silicone coating (a_LCPIDE030603WE06_diffCorr_A32-B32MR_DF20x). On the second spot, a bridge was formed between the traces and the problem seemed to come from lint contamination (a_LCPIDE030603WE06_lintCorr_B18-A19-B19MR_DF20x). The third failed device was LCPIDE030603WE4. After 18 months testing, the resistance of LCPIDE030603WE4 gradually dropped from 10^{12} to $10^8 \Omega$. The measurement for the device was terminated on 2/15/06. Microscopic exam showed a spot of dendrite corrosion (a_LCPIDE030603WE04_diffCorr_A14-B14M_DF20x & DF5x). The mark on the Au suggested the electrolysis of Au might be the cause for the corrosion. The greenish corrosion of Cu on the leads was also observed; however, neither bridge between the leads nor the leakage path can be identified. Finally, the resistance of LCPIDE030603WE10 remains at $10^{12} \Omega$ after 30 months measurement and the pass test is currently continuing for this last Rogers R-flex® 3600 device.

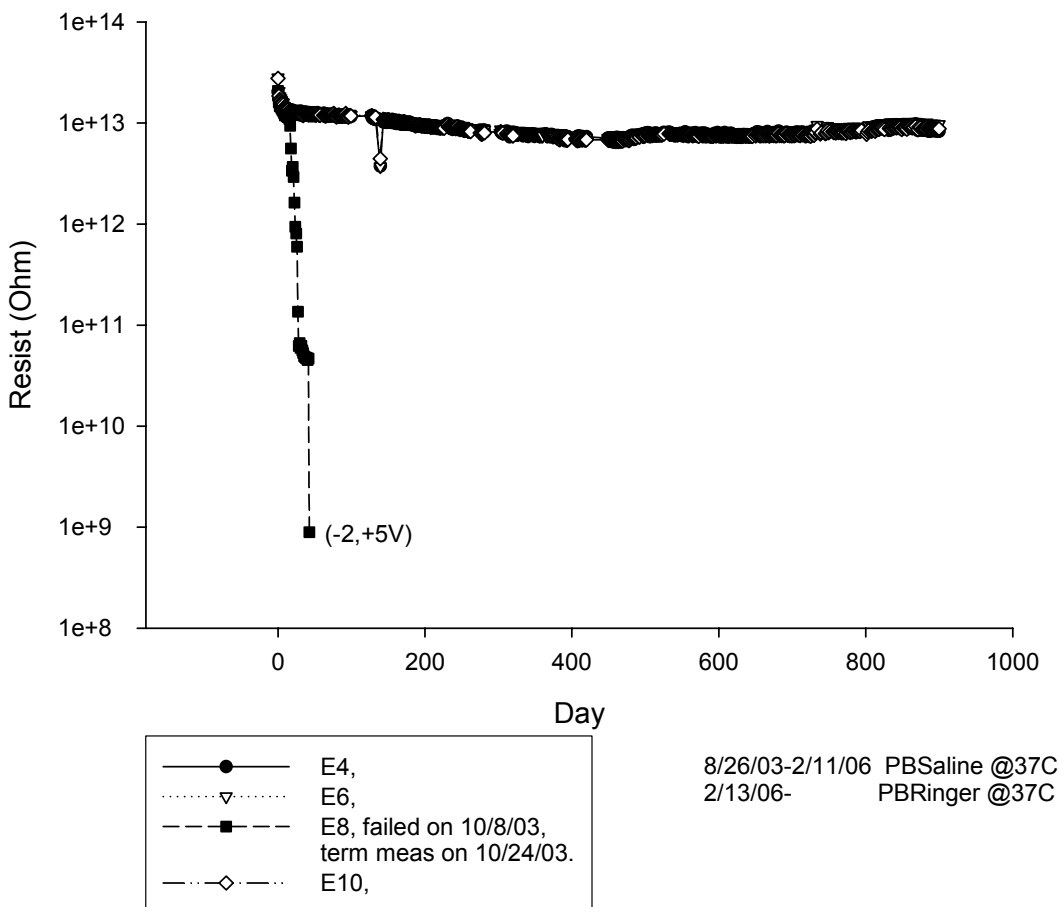
As for LCPIDE030603D Rogers R-flex[®] 3800 samples, the resistance for the most devices (LCPIDE030603DE4, E6, E10) has remained high from 2×10^{13} to 7×10^{12} Ω after 30 months test. The pass test for these devices is continuing. So far, the only Rogers R-flex[®] 3800 device failed is LCPIDE030603DE8. After less than one and half month testing, the resistance of LCPIDE030603DE8 quickly dropped from 10^{13} Ω (-5, +5V) to 10^8 Ω (-2, +5V). Microscopic exam showed the dendrite corrosions at location of A57-B57M (a_LCPIDE030603DE08__discolor_A57-B57M_DF20x).

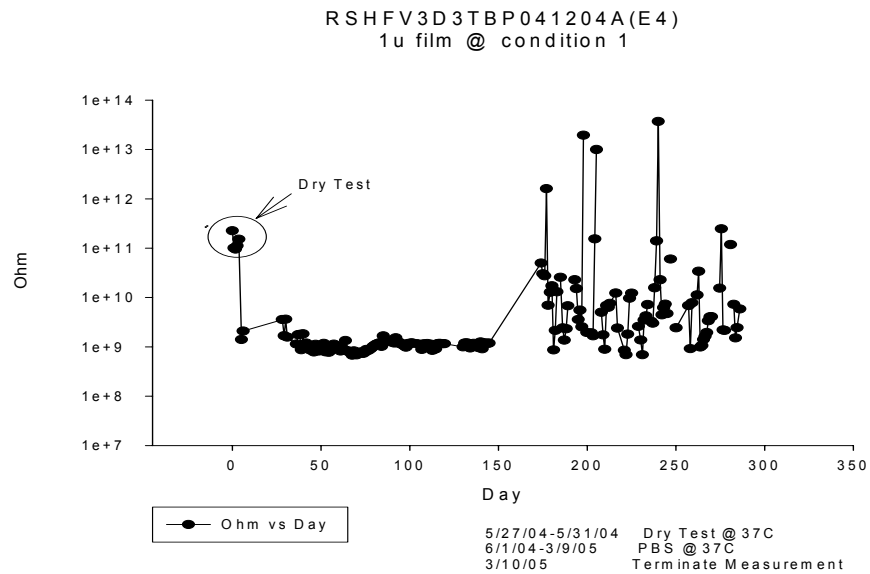
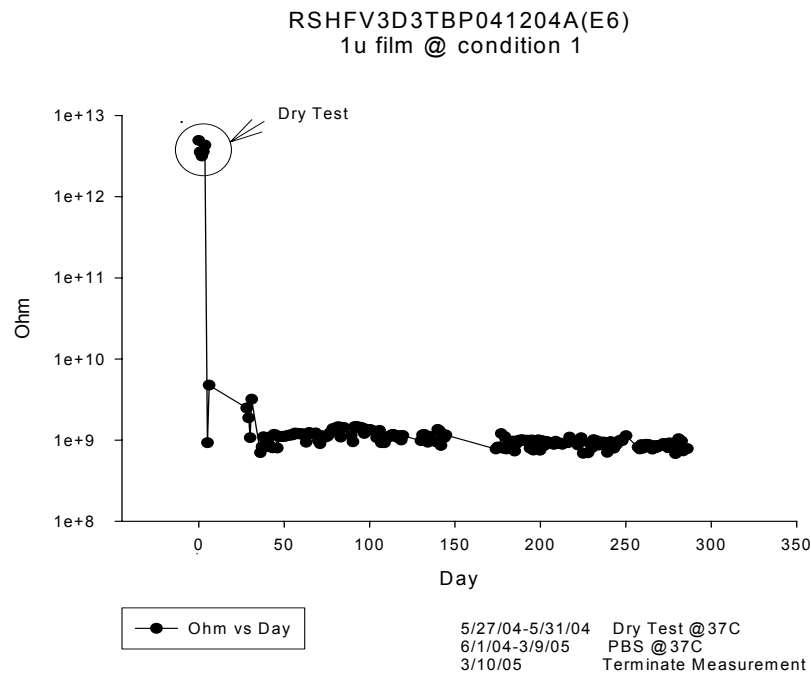
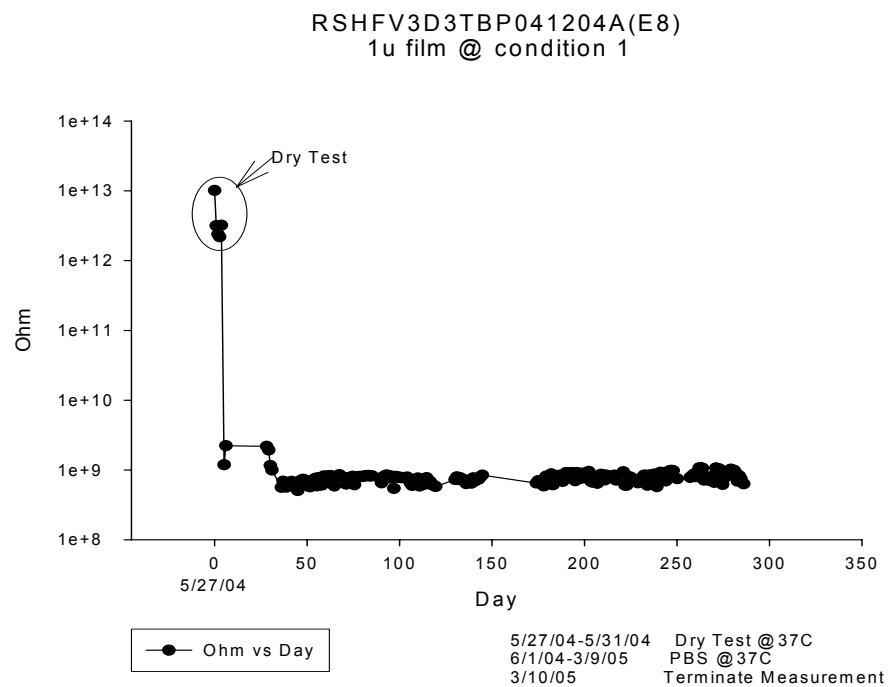
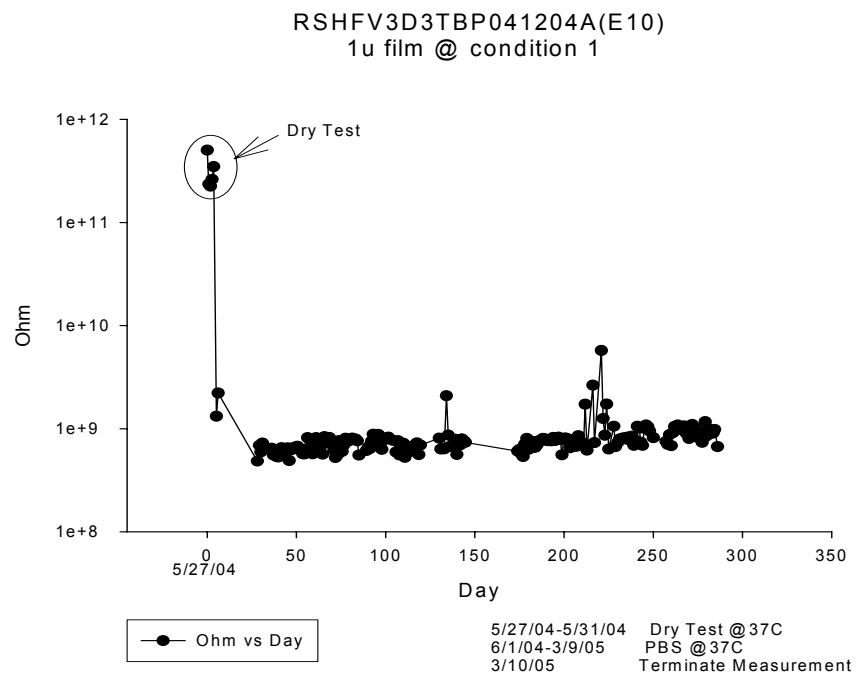
1μ film deposited at condition#1($P=300mT$, $T_f=500^0C$, $T_s=60^0C$) has the surface morphology of “star field”. The resistance data shows that in general RSHFV3D3TBP041204A has poor hermetic property. After soaking, resistance of all

four devices quickly dropped from $10^9\Omega$ to $10^8\Omega$ and the measurements were swept at limited range. The pass test was terminated on 3/10/05. Microscopic study after pass test showed extensive corrosion throughout the test surfaces, indicating general failure of the coating.

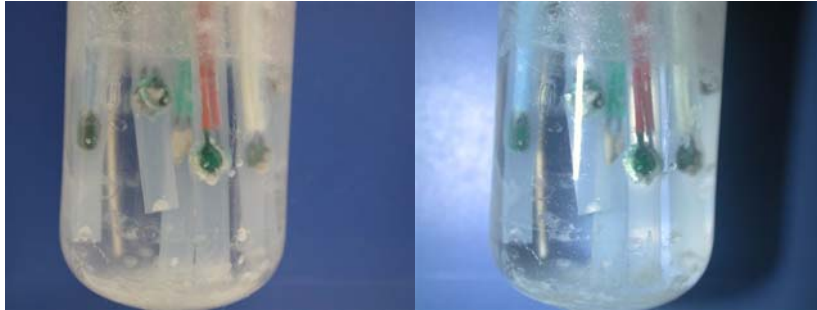
The failure points are clearly shown in this sample (Belden/Indium) noted as LBINDA:

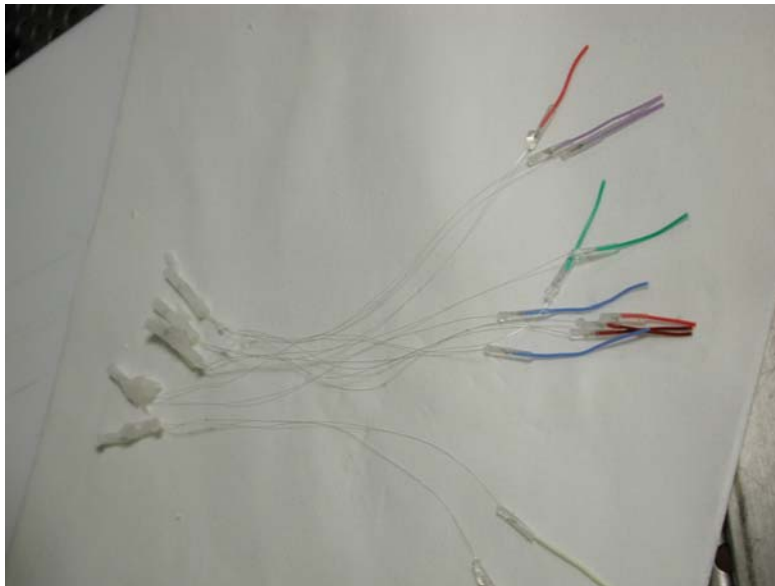
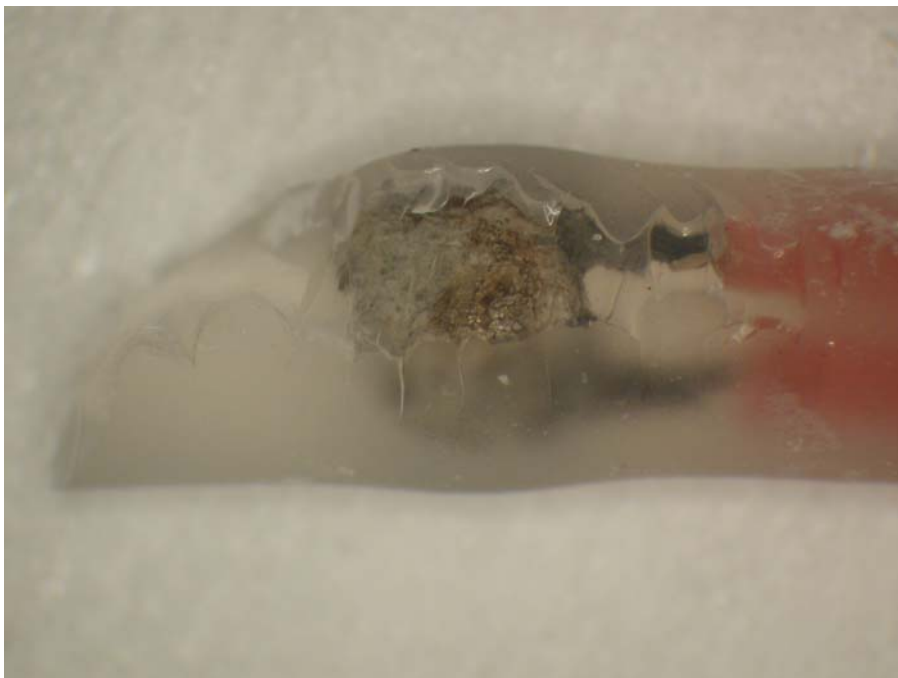
The first, LBINDA (Belden/Indium) showed no corrosion along the wires, though the solder was granular, gray and some had a brown stain.

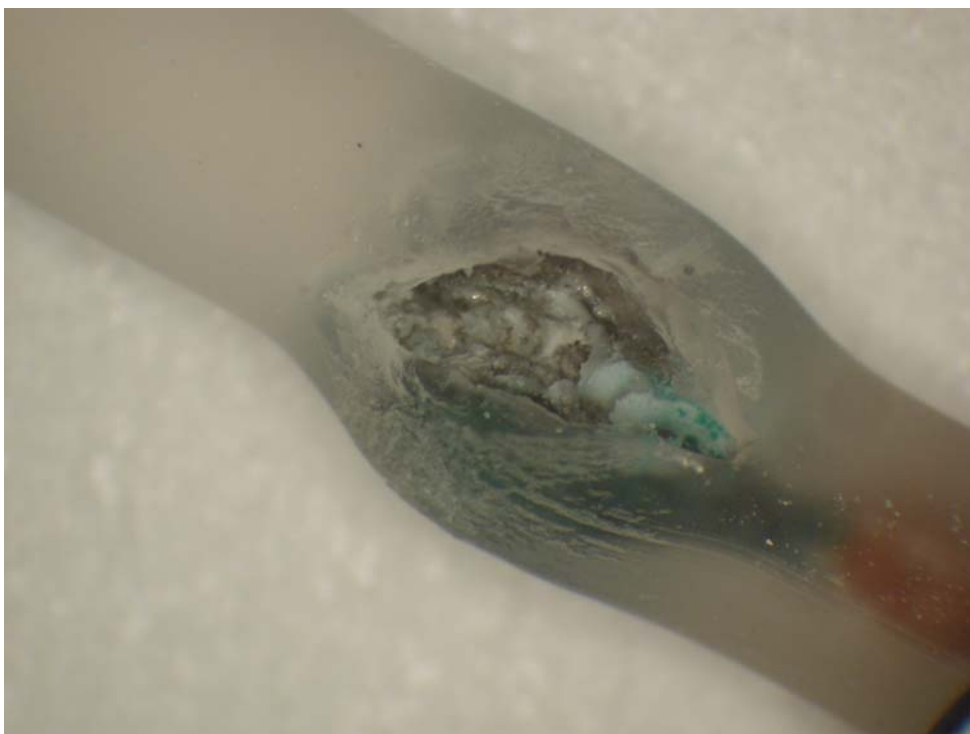
All, but one of the units was so swollen, that the silicone tubing had split.

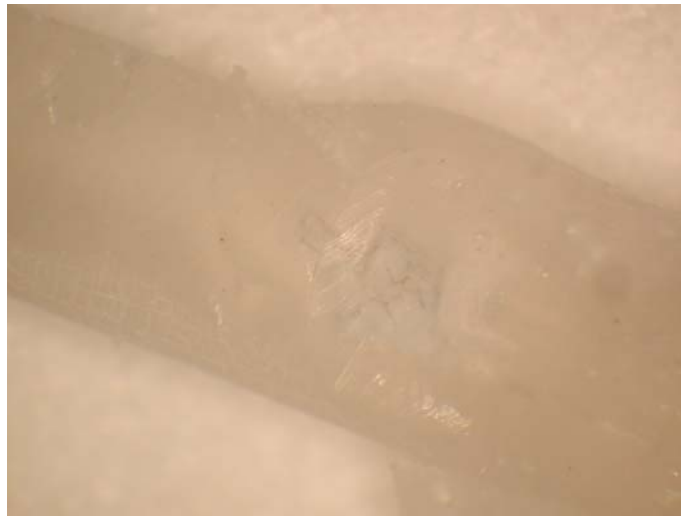
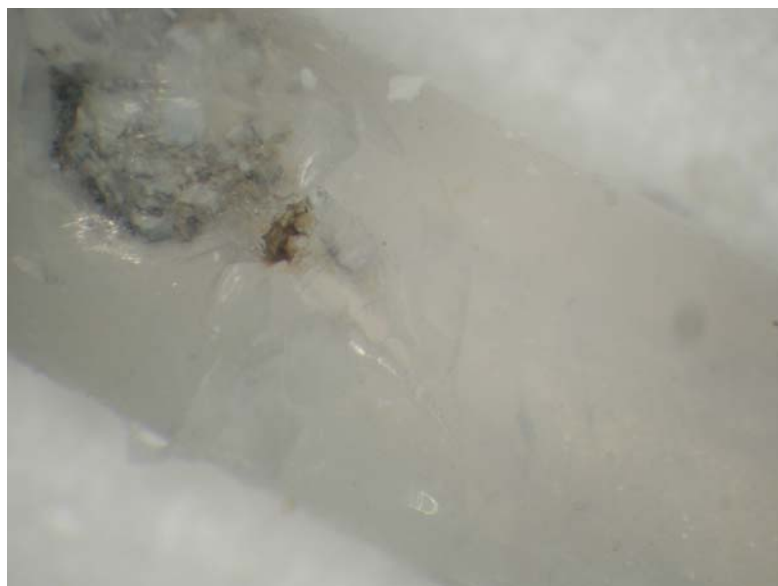
LAG62A

The construction of Ag wire and Kester solder Sn62 (LAG62A) showed no corrosion of the silver wire in the Teflon insulation, not even tarnish, and the conductivity across the Belden/Ag wires was tested and found to be fine. The solder showed a “crystalline” surface with black cracks.

After removing the silicone tubing, it was evident that the corrosion had occurred on the length of uninsulated wire before the solder joint, the area that had been flamed to remove the Teflon coating prior to soldering. This area, then, had not been covered by the solder joint.

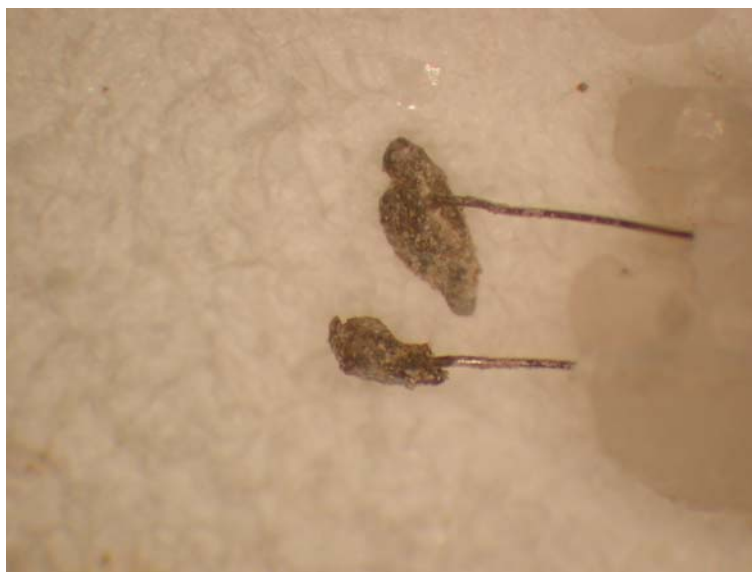
The third construction that totally failed was LPI62A (Platinum/Iridium wire/Kester solder Sn62). In this unit, the solder connections are oxidized to a white color and in some, the solder joint is broken apart.

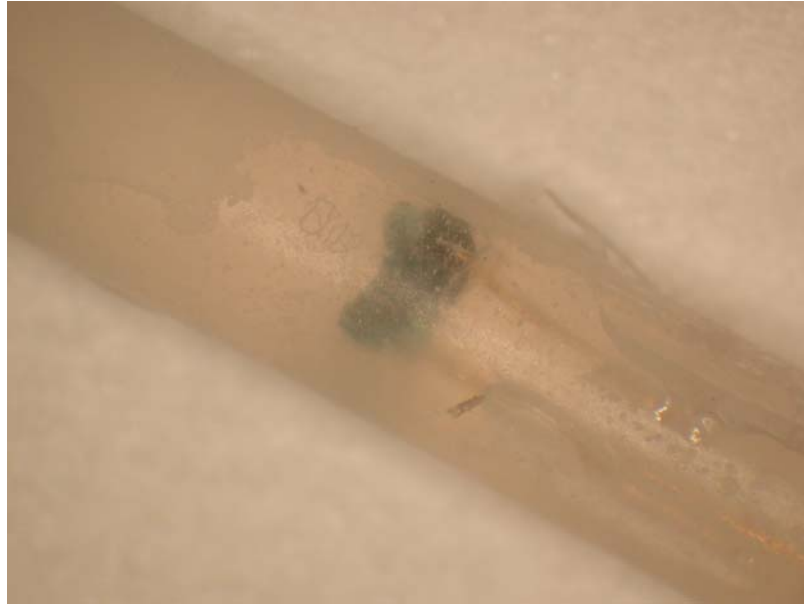
The last construction that failed totally is LAUSSA (Au wire/silver silicone). This construction never gave any reasonable readings. All connections were unstable. In this construction the corrosion at the end of the gold wires was green which is odd – prior gold corrosions were distinctively purple.

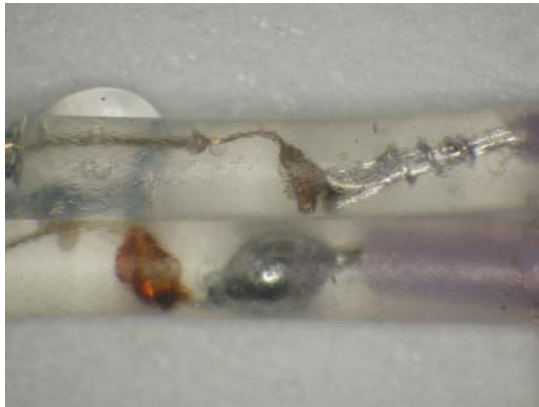
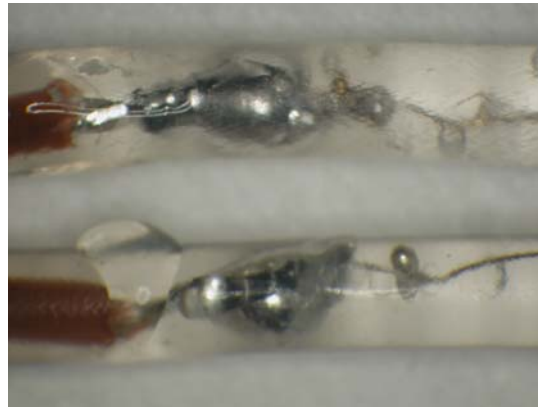
In the pictures below, discoloration at the gold/Belden join is evident, probably caused by incomplete removal of flux. The joints between the Belden/Silver/Gold joints were verified as conductive and not the failure point.

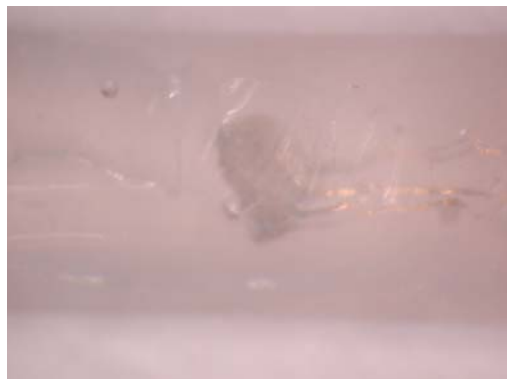
The silver silicone joints were essentially non-corroded as shown below:

The unstable readings from these silver silicone samples may be explained by the level of silver in the silver silicone more than a failure of any of the joints since they were unreliable from the beginning and showed no corrosion.
